# Payson Park

## Town of Belmont ADA Transition Plan

August 2021

Institute for Human Centered Design

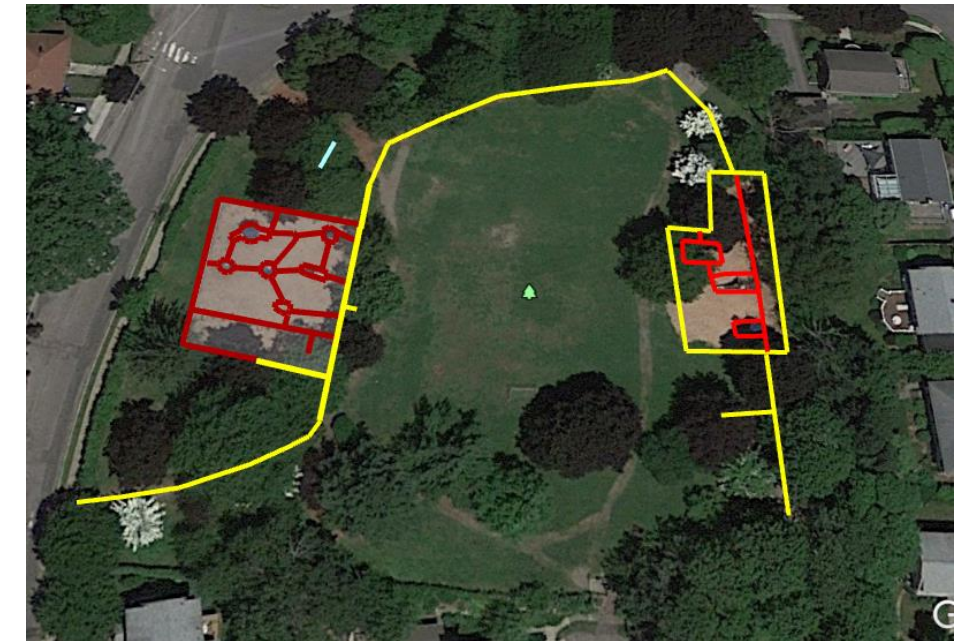
Accessibility issues include lack of an accessible route to and around the two playgrounds. There is also a lack of an impact-attenuating accessible route to the play components inside the boundary of the playgrounds. See the following diagram depicting accessible routes to and around the playgrounds from entrances (in yellow) and to the play components in the playgrounds (in red). A stone dust route to the bike rack is shown in light blue.

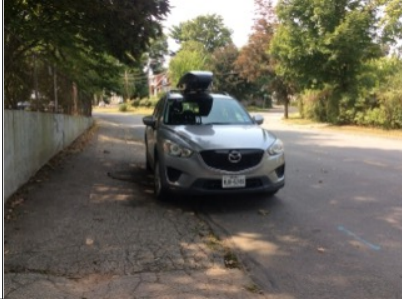
Cross slope > 1:50 (2.00%)	7.4%	Reduce cross slope to be no steeper than 1:50 (2.00%).(Cost estimate to renovate 100' of sidewalk.)	1	4000	\$4000
2	Main Entrance	Ext.		Exterior Access Route	Walkway

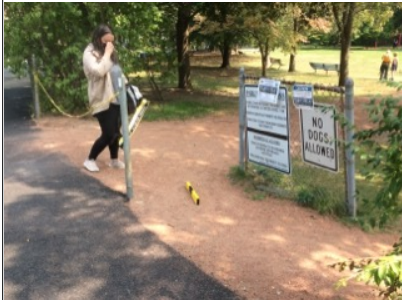
Running slope > 1:20 (5%)	7.8%	Reduce running slope to be no steeper than 1:20 (5%). (Cost estimate for 10' long, 4' wide asphalt route.)	1	400	\$400
3	Walkway by Main Entrance	Ext.		Exterior Access Route	Walkway

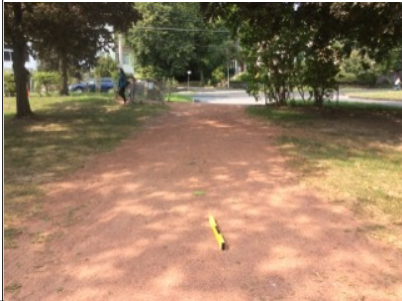
Running slope > 1:20 (5%)	6.5%	Reduce running slope to be no steeper than 1:20 (5%). (Cost estimate for 10' long, 4' wide route.)	1	400	\$400
4	South Payson Street Entrance	Ext.		Exterior Access Route	Exterior

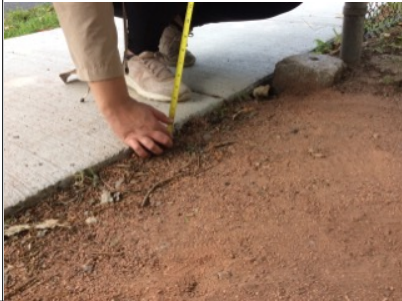
Level changes > 1/4"	1.25"	Alter change in level to be 1/4" high max.	1	160	\$160

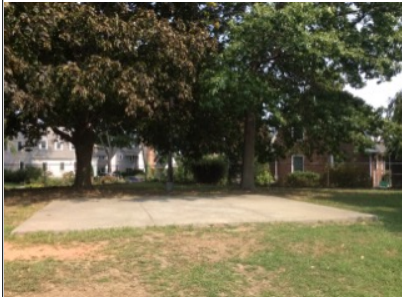
5	Band Stand	Ext.		Exterior Access Route	Walkway

Accessible route not provided	-	Ensure an accessible route is provided. (Cost estimate for 177' long, 4' wide asphalt walkway.)	1	5664	\$5664

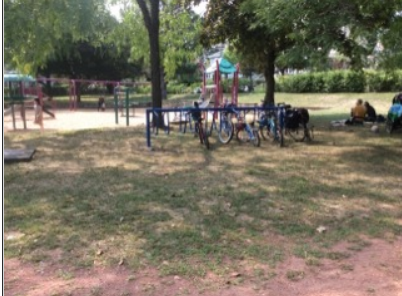
Accessible route not provided	-	Ensure an accessible route is provided to the bike rack. (Cost estimate for 15' long, 4' wide stone dust route.)	1	480	\$480
7	Bulletin Board and Defibrillator in Grass Field by Picnic Area	Ext.		Exterior Access Route	Walkway

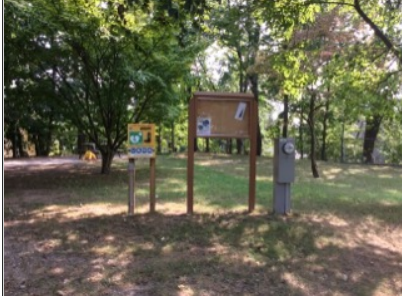
Accessible route not provided	-	Ensure an accessible route is provided. (Cost estimate for 24' long, 4' wide asphalt route.)	1	960	\$960
8	Walking Route Between Playground and South Payson Street Entrance	Ext.		Exterior Access Route	Exterior

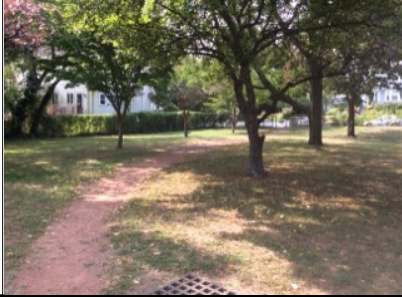
Accessible route not provided	-	Provide an accessible route. (Cost estimate for 4' wide by 109' long asphalt route.)	1	4360	\$4360
9	Walking Route on North Side	Ext.		Exterior Access Route	Exterior

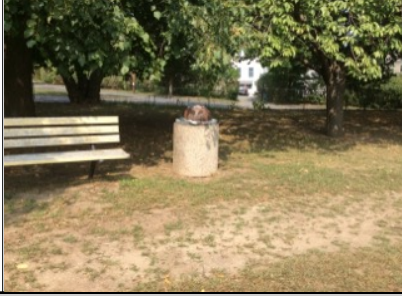
Accessible route not provided	-	Ensure an accessible route is provided to the trash container. (Cost estimate for 6' long by 4' wide asphalt route.)	1	240	\$240

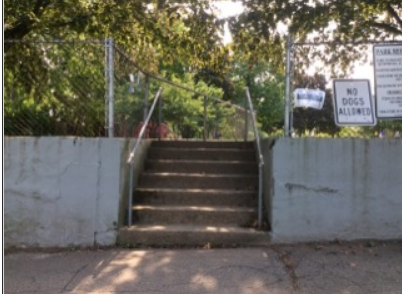
<b>Entrance</b>												
10	Elm Street Entrance	Ext.		Entrance	Secondary Entrance

Directional sign to accessible entrance not provided	-	Provide a directional sign indicating the location of the nearest accessible entrance.	1	346	\$346

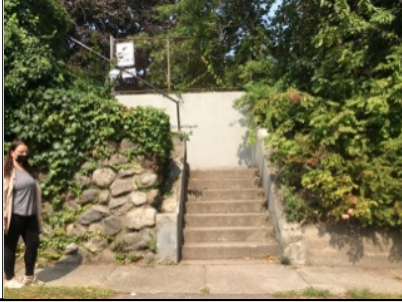
Directional sign to accessible entrance not provided	-	Provide a directional sign indicating the location of the nearest accessible entrance.	1	346	\$346
<b>Access to Goods and Services</b>												
<b>Signage</b>												
12	Main Entrance	Ext.		Signage	Informational

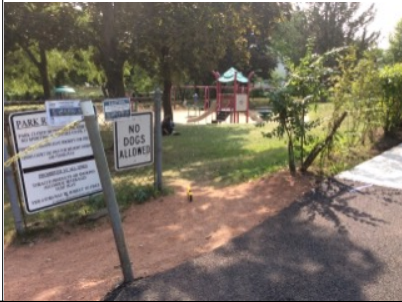
Visual characters < 40" above ground	-	Mount visual sign so that the baseline of the lowest character is 40" min. above the finished floor.	1	Labor	\$0
<b>Picnic Tables</b>												
13	Gravel Picnic Area on Southeast Side	Ext.		Picnic Tables	N/A

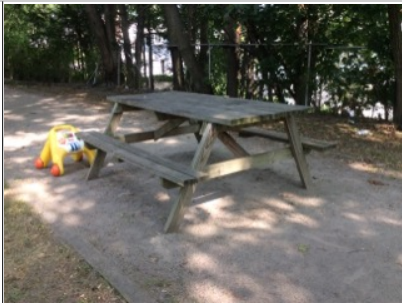
Toe or knee clearance at tables not provided	6"	Provide at least 1 picnic table with knee and toe clearance that is 17" deep minimum.	1	1400	\$1400
14	Gravel Picnic Area on Southeast Side	Ext.		Picnic Tables	N/A

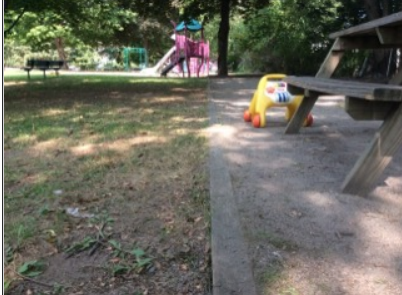
Picnic table not on an accessible route	-	Ensure that the dining surface is connected to an accessible route. (Cost estimate for a 75' long, 4' wide asphalt route to the picnic table.)	1	3000	\$3000

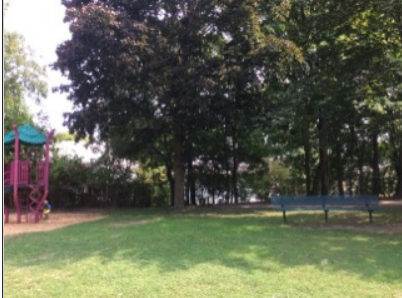
No accessible route to one bench in area	-	Provide an accessible route to the bench. (Cost estimate for 10' long by 4' wide asphalt route.)	1	400	\$400
16	Walking Route on North Side	Ext.		Exterior Benches	N/A

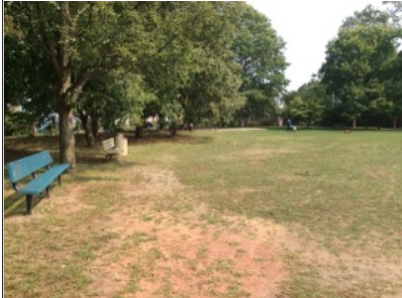
No accessible route to one bench in area	-	Provide an accessible route to one bench in this area. (Cost estimate based on 6' long, 4' wide asphalt route.)	1	240	\$240
17	West Playground	Ext.		Exterior Benches	N/A

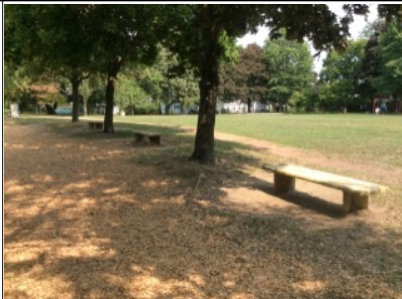
No accessible route to one bench in area	-	Provide an accessible route to one bench. (Cost estimate for 4' wide by 5' long asphalt route.)	1	200	\$200
<b>Play and Sport Areas</b>												
<b>Play Areas</b>												
18	East Playground	Ext.		Play Areas

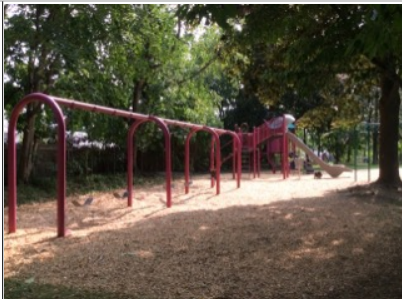
Accessible route not provided to playground	-	Install an accessible route to the playground. (Cost estimate for 66' long by 4' wide asphalt route.)	1	3300	\$3300

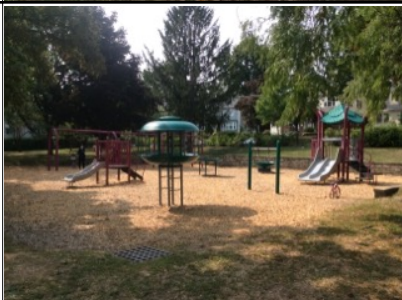
19	West Playground	Ext.		Play Areas	N/A

Accessible route not provided to playground Accessible route not provided around playground	- -	Install an accessible route to and around the playground. (Cost estimate for 150 ft. long, 4 ft. wide stone dust route to and around the playground.)	1	4800	\$4800

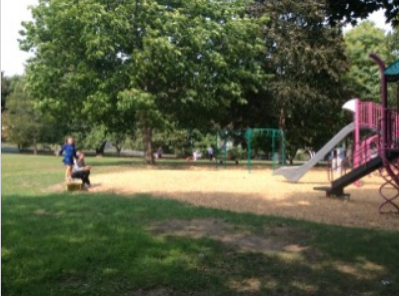
Accessible route not provided around playground	-	Provide an accessible route around the play area (including route to at least one bench). (Cost estimate for 288' long by 4' wide asphalt route around playground.)	1	11520	\$11520
21	East Playground	Ext.		Play Areas	N/A

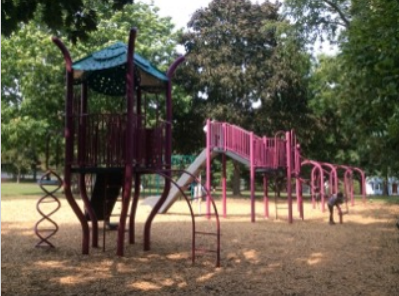
Accessible route not provided to play components	-	Provide a compliant impact-attenuating surface to and around the play components. (Cost estimate for 1,250 sq. ft. of poured in place rubber surface.)	1	17500	\$17500
22	West Playground	Ext.		Play Areas	N/A

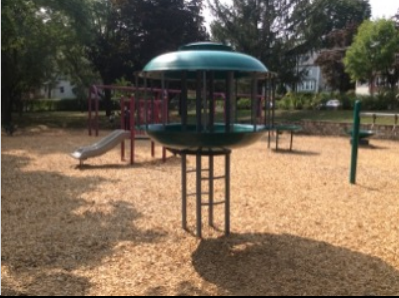
Accessible route not provided to play components	-	Provide a compliant impact-attenuating surface to and around the play components. (Cost estimate for 2,917 sq. ft. of poured in place rubber surface.)	1	40838	\$40838

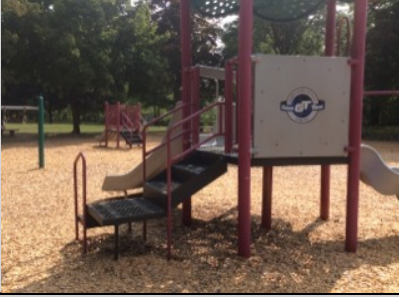
23	West Playground	Ext.		Play Areas	N/A

No compliant transfer system	20.75"	Alteration of component might be technically infeasible. When playground is resurfaced with poured-in-place rubber ensure that transfer platform is 11" to 18" high above the ground surface.	1	Labor	\$0
<b>Field</b>												
24	Grass Field With Soccer Net	Ext.		Field	Soccer

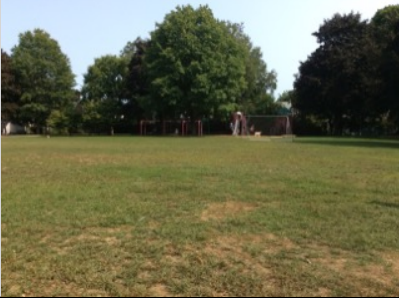
Field not connected to an accessible route	-	Provide an accessible route to the field. (Cost estimate for 4' wide by 5' long stone dust route.)	1	160	\$160
<b>Best Practice</b>

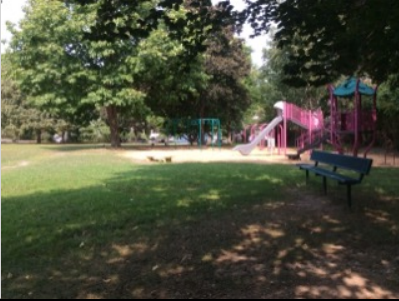
Recommend providing clear floor space alongside at least one bench in each area where benches are provided so that a wheelchair user can sit shoulder to shoulder with a person seated at the bench.	1	-	\$0
26	Gravel Picnic Area on Southeast Side	Ext.

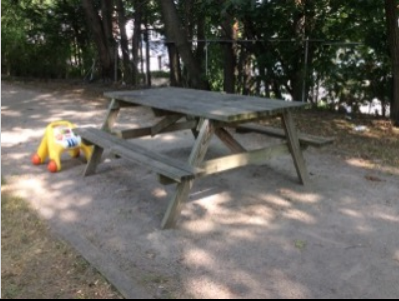
Recommend providing a 48" wide stable, firm and slip resistant walking surface around accessible picnic tables.	1	-	\$0
27	Van Ness Road Entrance	Ext.

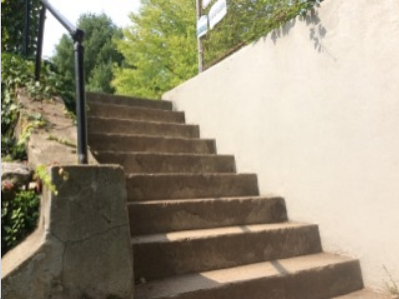
Recommend providing handrails on both sides of stairs. Recommend providing contrasting strips on each stair tread.	1	-	\$0
