Fire Station 2

Town of Belmont ADA Transition Plan

February 2021

**Town of Belmont
Fire Station 2**

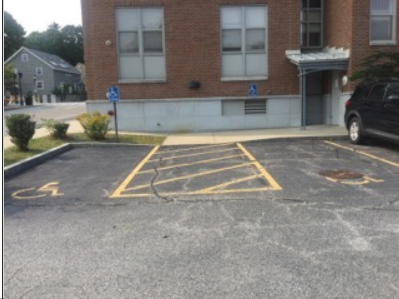
Total # of parking Total # of designated accessible parking spaces Total # of designated van accessible spaces Sign bottom < 60" above finished grade	17 1 1 52"	Locate the van accessible sign with the bottom of the sign 60" min. above the ground.	1	Labor	\$0
Emergency Exit												
2	Main Entrance (Egress)	1		Emergency Exit	N/A

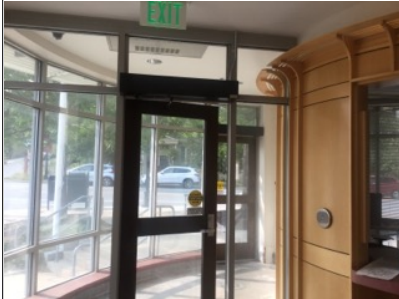
Tactile sign not provided at exit Illuminated Int. Symbol of Acc. not provided (MAAB)	- -	Provide tactile exit signs with raised characters and braille at exit doors. Mount signs between 48"- 60" above the finished floor located on the latch side of the door. Provide an illuminated sign with the International Symbol of Accessibility.	1	432	\$432

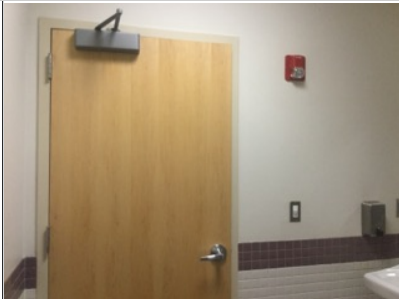
Access to Goods and Services												
Doors, Doorways, & Gates												
3	Women's Toilet Room	1		Doors, Doorways, & Gates	Toilet Room

Door requires > 5 lbs. of force to open	7 lbs.	Adjust closers so doors do not require more than 5 pounds of force to open.	1	Labor	\$0
Signage												
4	Study	2	201	Signage	Designation

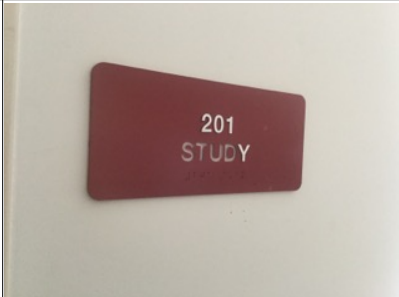
Raised characters not provided on sign	-	Provide text with raised characters duplicated in braille on sign. Some raised characters are missing from the sign.	1	232	\$232

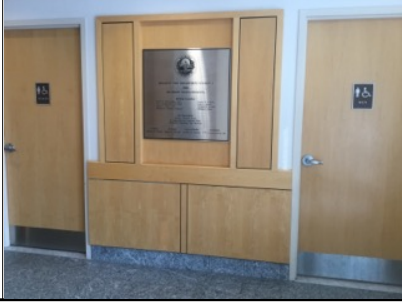
ID	Location	Floor	Room	Element	Type	Photo	Issues	Current Measure	Recommendations	Quantity	Price	Cost Estimation
5	Toilet Rooms - Main Entrance	1		Signage	Designation

Sign not located on the latch side of the door	-	Locate sign at permanent rooms alongside the door on the latch side.	2	Labor	\$0
Operable Parts												
6	Main Entrance	1		Operable Parts	Other

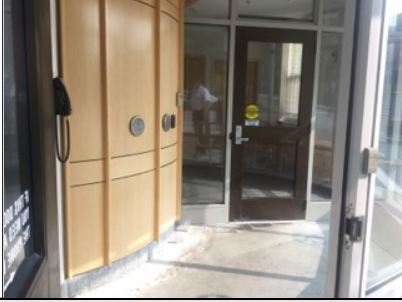
Reach < 15" or > 48"(forward/side approach)	55.5"	Relocate telephone to be no higher than 48" above the finished floor.	1	Labor	\$0
Toilet & Bathing Rooms												
Single-User Toilet												
7	Men's and Women's Toilet Room	1		Single-User Toilet	N/A

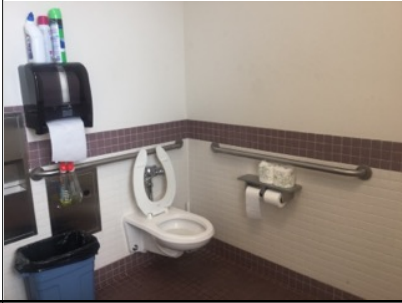
Dispenser mounted over grab bar		Relocate paper towel dispenser so that it is not mounted above the grab bar.	2	256	\$512
Best Practice												
8	Stair 1	1

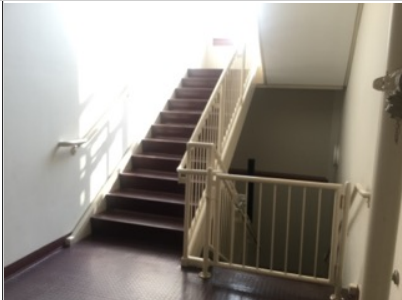
Recommend providing contrast strips at each stair tread.	1	-	\$0

- Recommend providing contrast strips at each stair tread at Stair 1 and the exterior stairs by the main entrance.

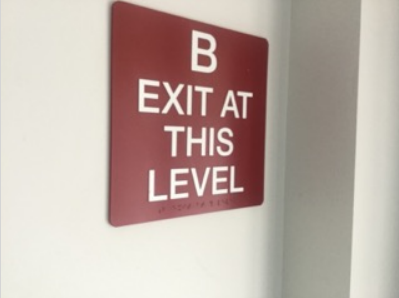
ID	Location	Floor	Room	Element	Type	Photo	Issues	Current Measure	Recommendations	Quantity	Price	Cost Estimation
9	Stair Exit Sign From Stair 2	1

Good example of a raised character and braille egress sign.	1	-	\$0
10	Corridor	2

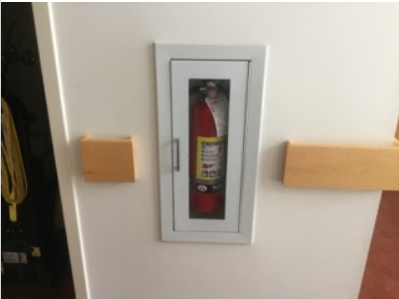
This is a good example of recessing a fire extinguisher cabinet.	1	-	\$0
11	Main Entrance	Ext.
